Brief update of mitigation studies at KEKB

Y. Suetsugu

KEK

2010.06.16

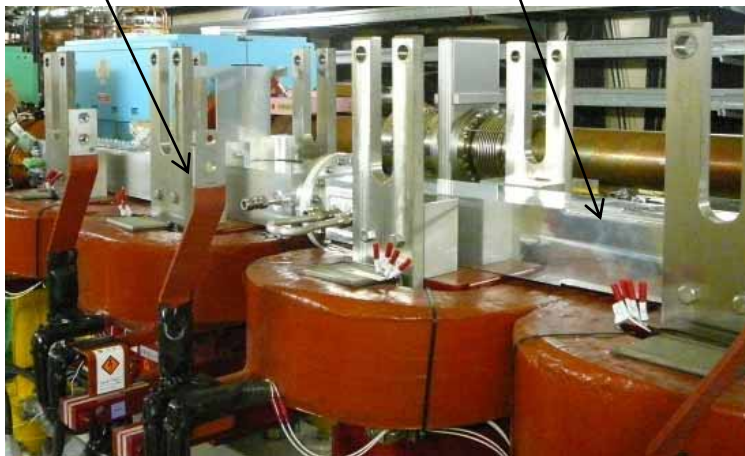
Second test chamber

- Experiment using **another** test chamber with a **new** electron monitor with RFA.
 - Just downstream of the test chamber in the test #1
 - **The structure of electron monitor was improved: smaller holes, more collectors.**
- Inside of a wiggler magnet (0.78 T)
- Since 2009.

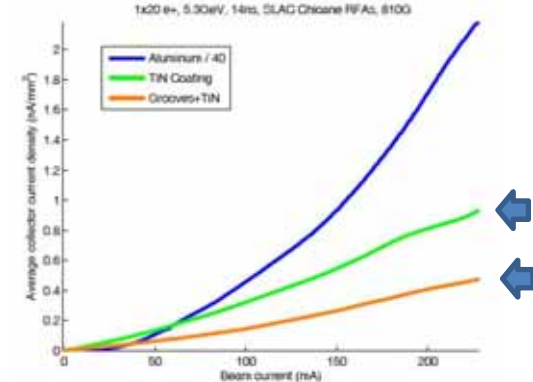
IPAC10, TUPD023

- The result in Test #2 is consistent with that in CESR-TA.
 - The electron current for a TiN-coated groove is a half of that for a flat surface with TiN (Cu).
- If so, the Al grooves (w/o coating) might be not so effective as indicated in the result of test #1.

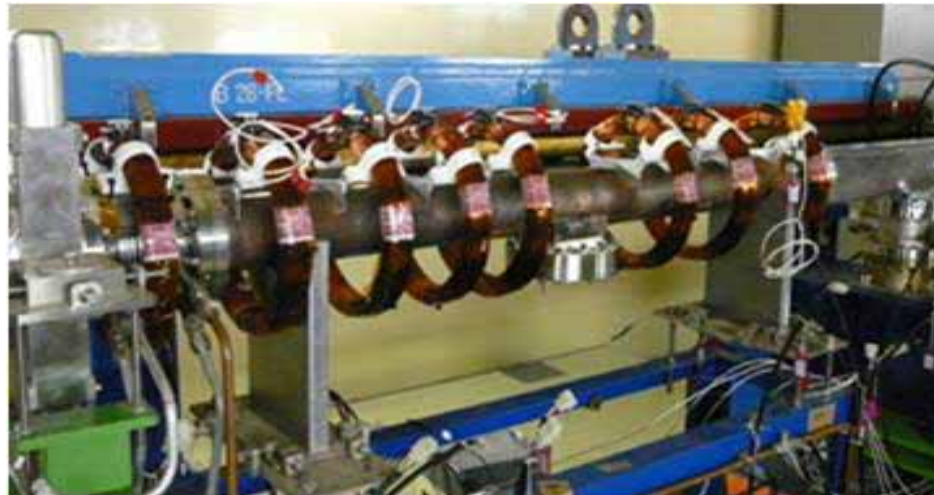
- Experiment using a test chamber with an electron monitor with RFA installed **at a magnetic free region.**
 - Circular beam pipe
- Since 2006.
- Copper and aluminum pipe with/without coatings, such as TiN, NEG, DLC, have been tested.

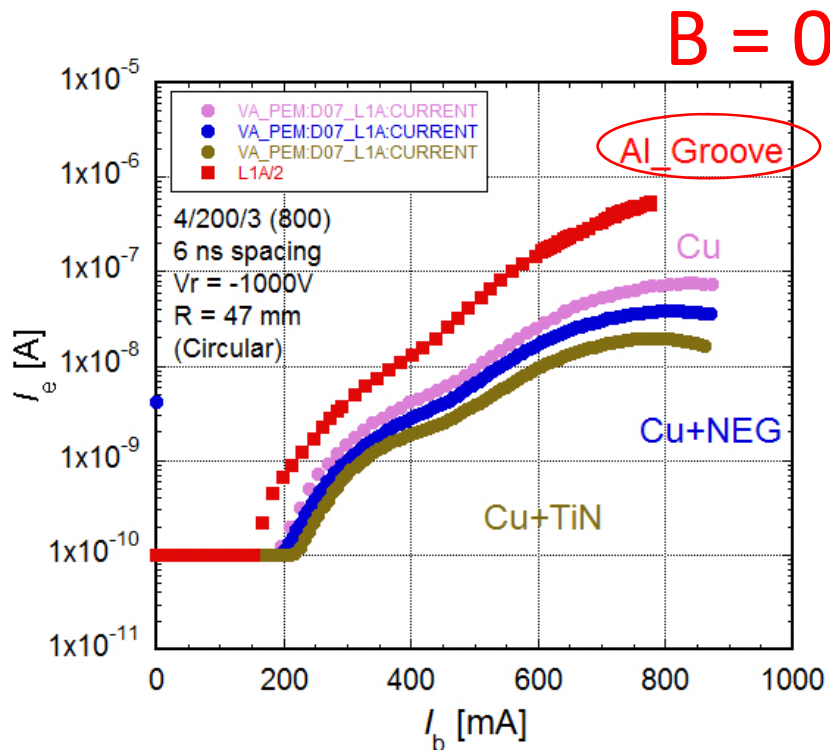
- Electron currents vs. beam current
- The electron current for the groove is smaller than that for a flat Al surface by a factor of 2, but much larger than that for a flat Cu surface.
- More effective at low beam current regime?.

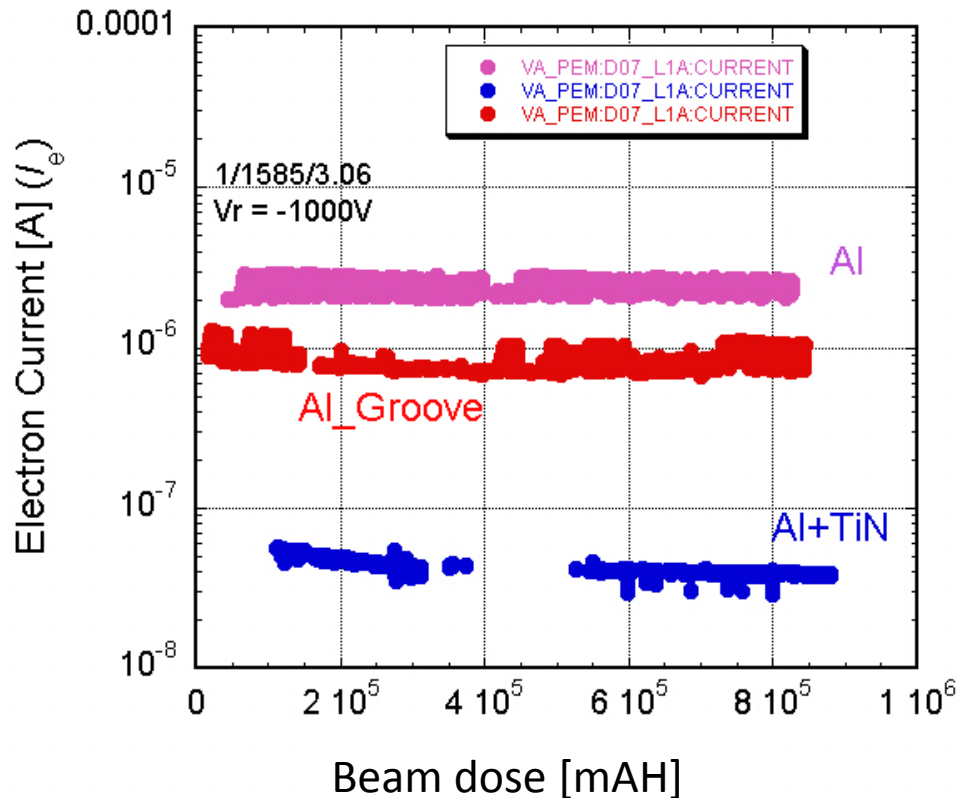
B = 0

- Change of electron currents (central part) against beam does.
- Triangular grooves are more effective in a dipole magnetic field than in a magnetic free condition??
 - Need further investigation.
