CBETA Production Magnets

Production complete excl. spares!

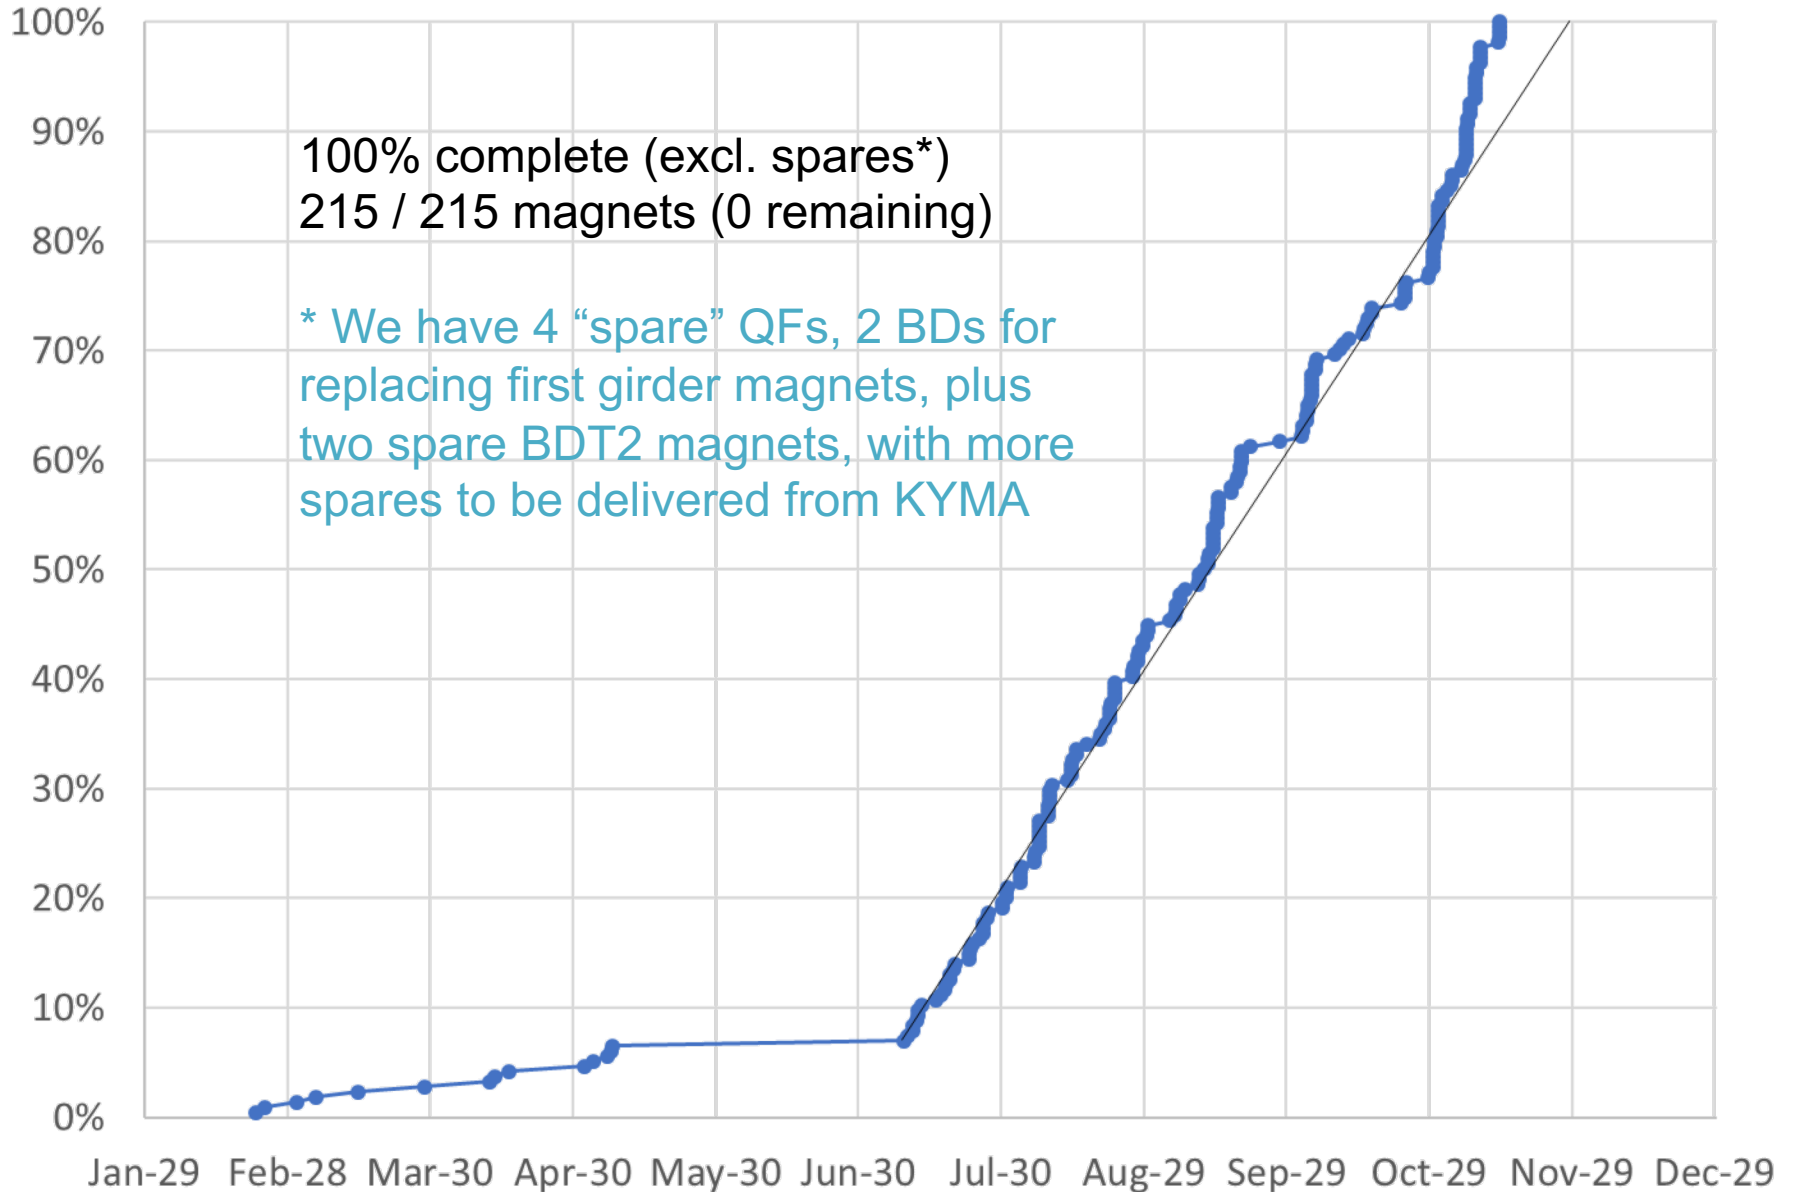
Fraction of Magnets Tuned

— BDT1 fraction — BDT2 fraction — BD fraction — QD fraction — QF fraction

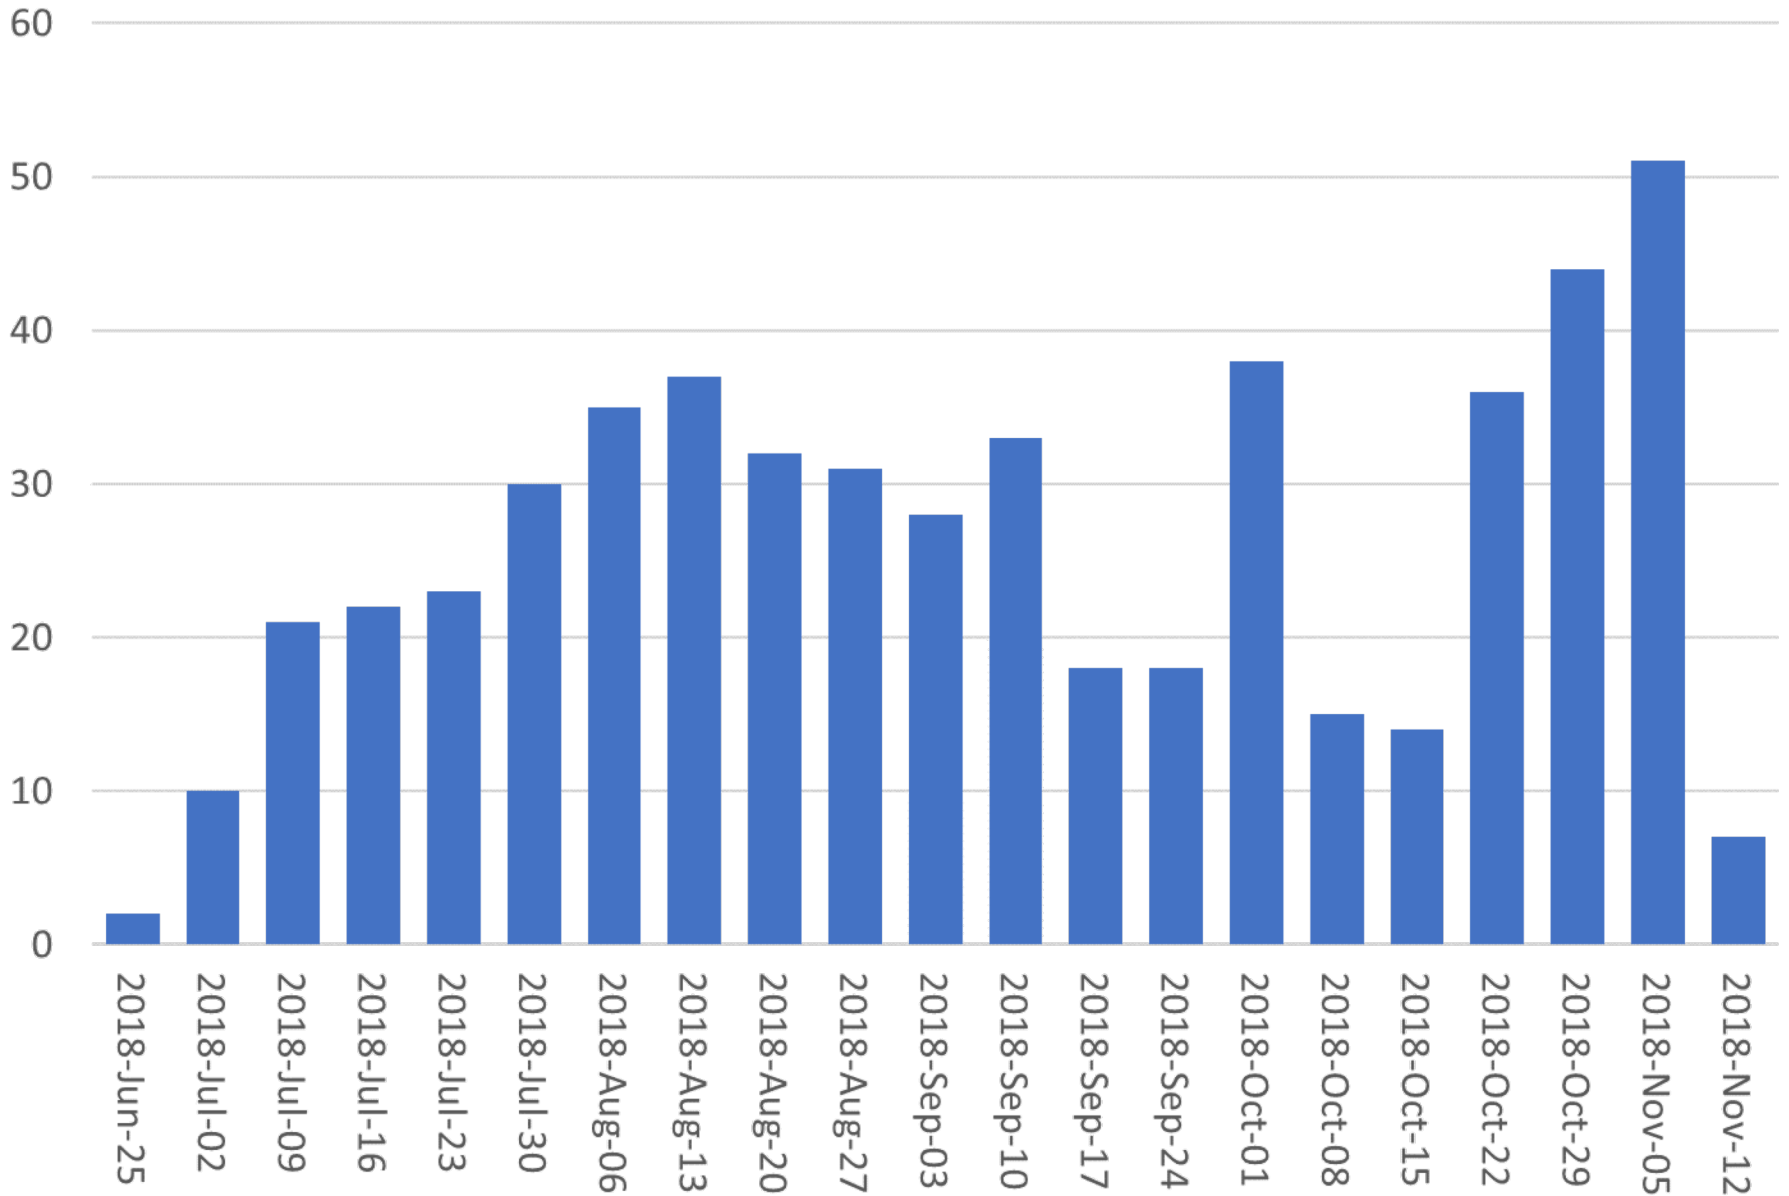
Coil Measurements Per Week

Main Production	
Magnets tuned	200 (excl. early samples)
Rotating coil measurements	545
Start date	July 9, 2018
End date	November 14, 2018
Total weeks	18.2
Magnets tuned per week (avg.)	10.96
Rotating coil meas. per week (avg.)	29.88
Rotating coil meas. per magnet (avg.)	2.73

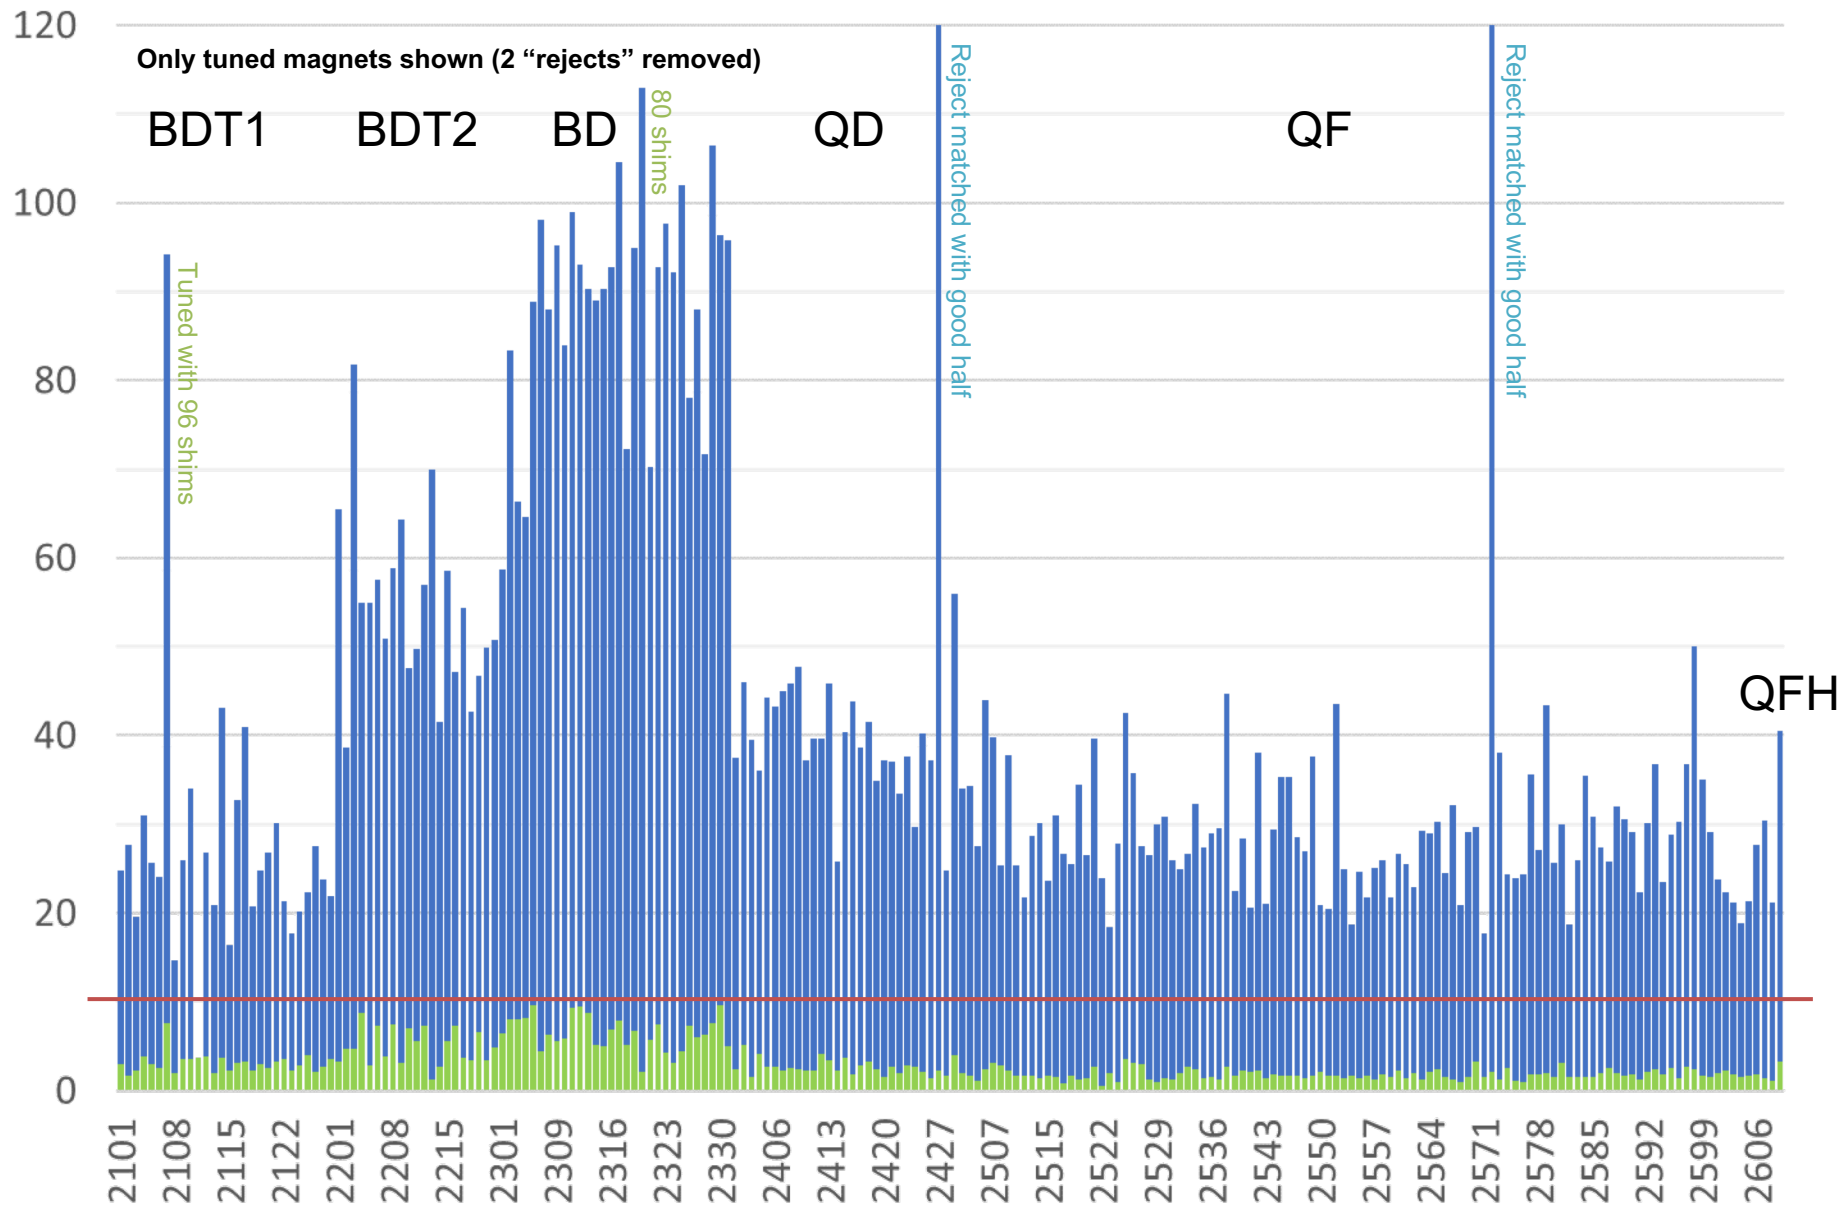
■ Initial FOM (units) ■ Tuned FOM (units)

Midplane error (G)	Units FOM	CBETA FOM	Quad error at x=0 (rel.)
≤ 1.5	≤ 10	≤ 0.375	$\leq 0.05\%$ (Q)

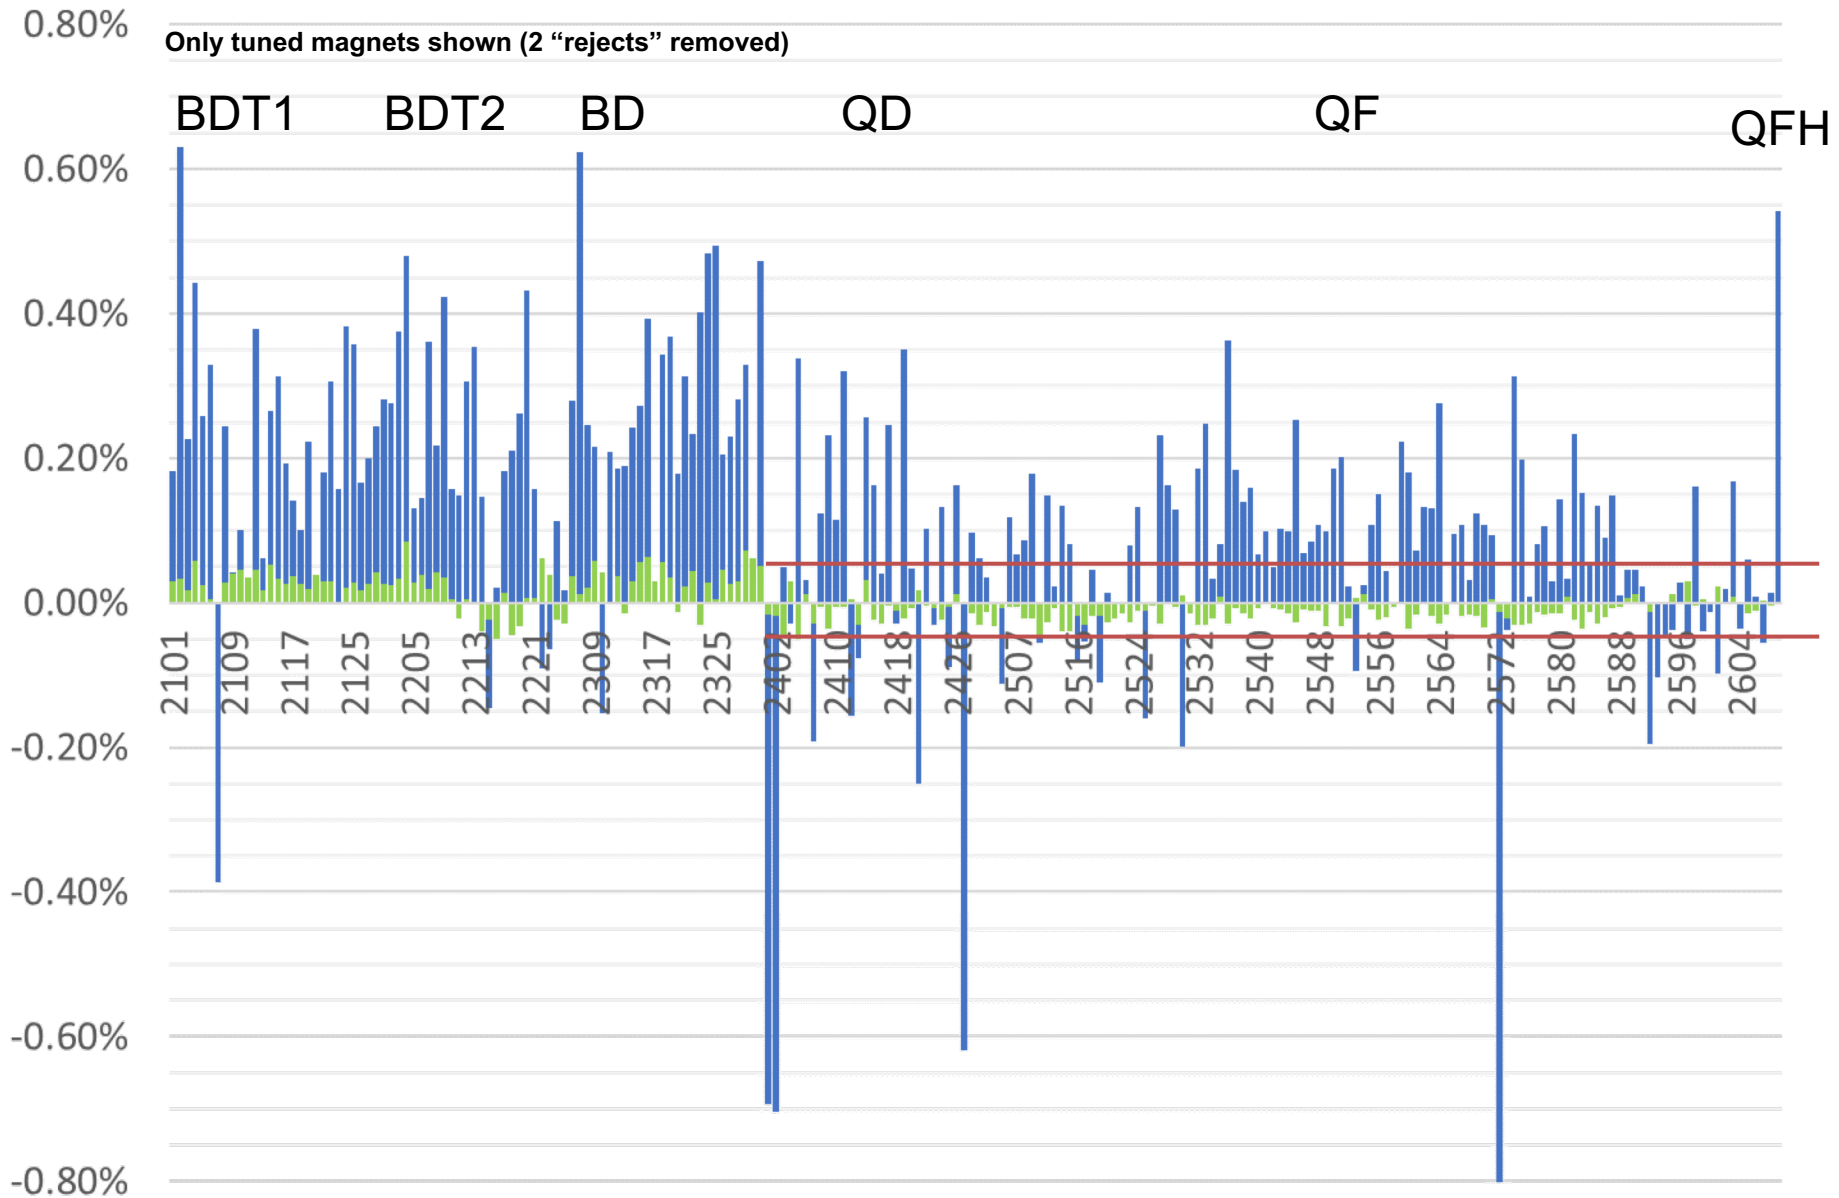
■ Initial quad error (rel.) ■ Tuned quad error (rel.)

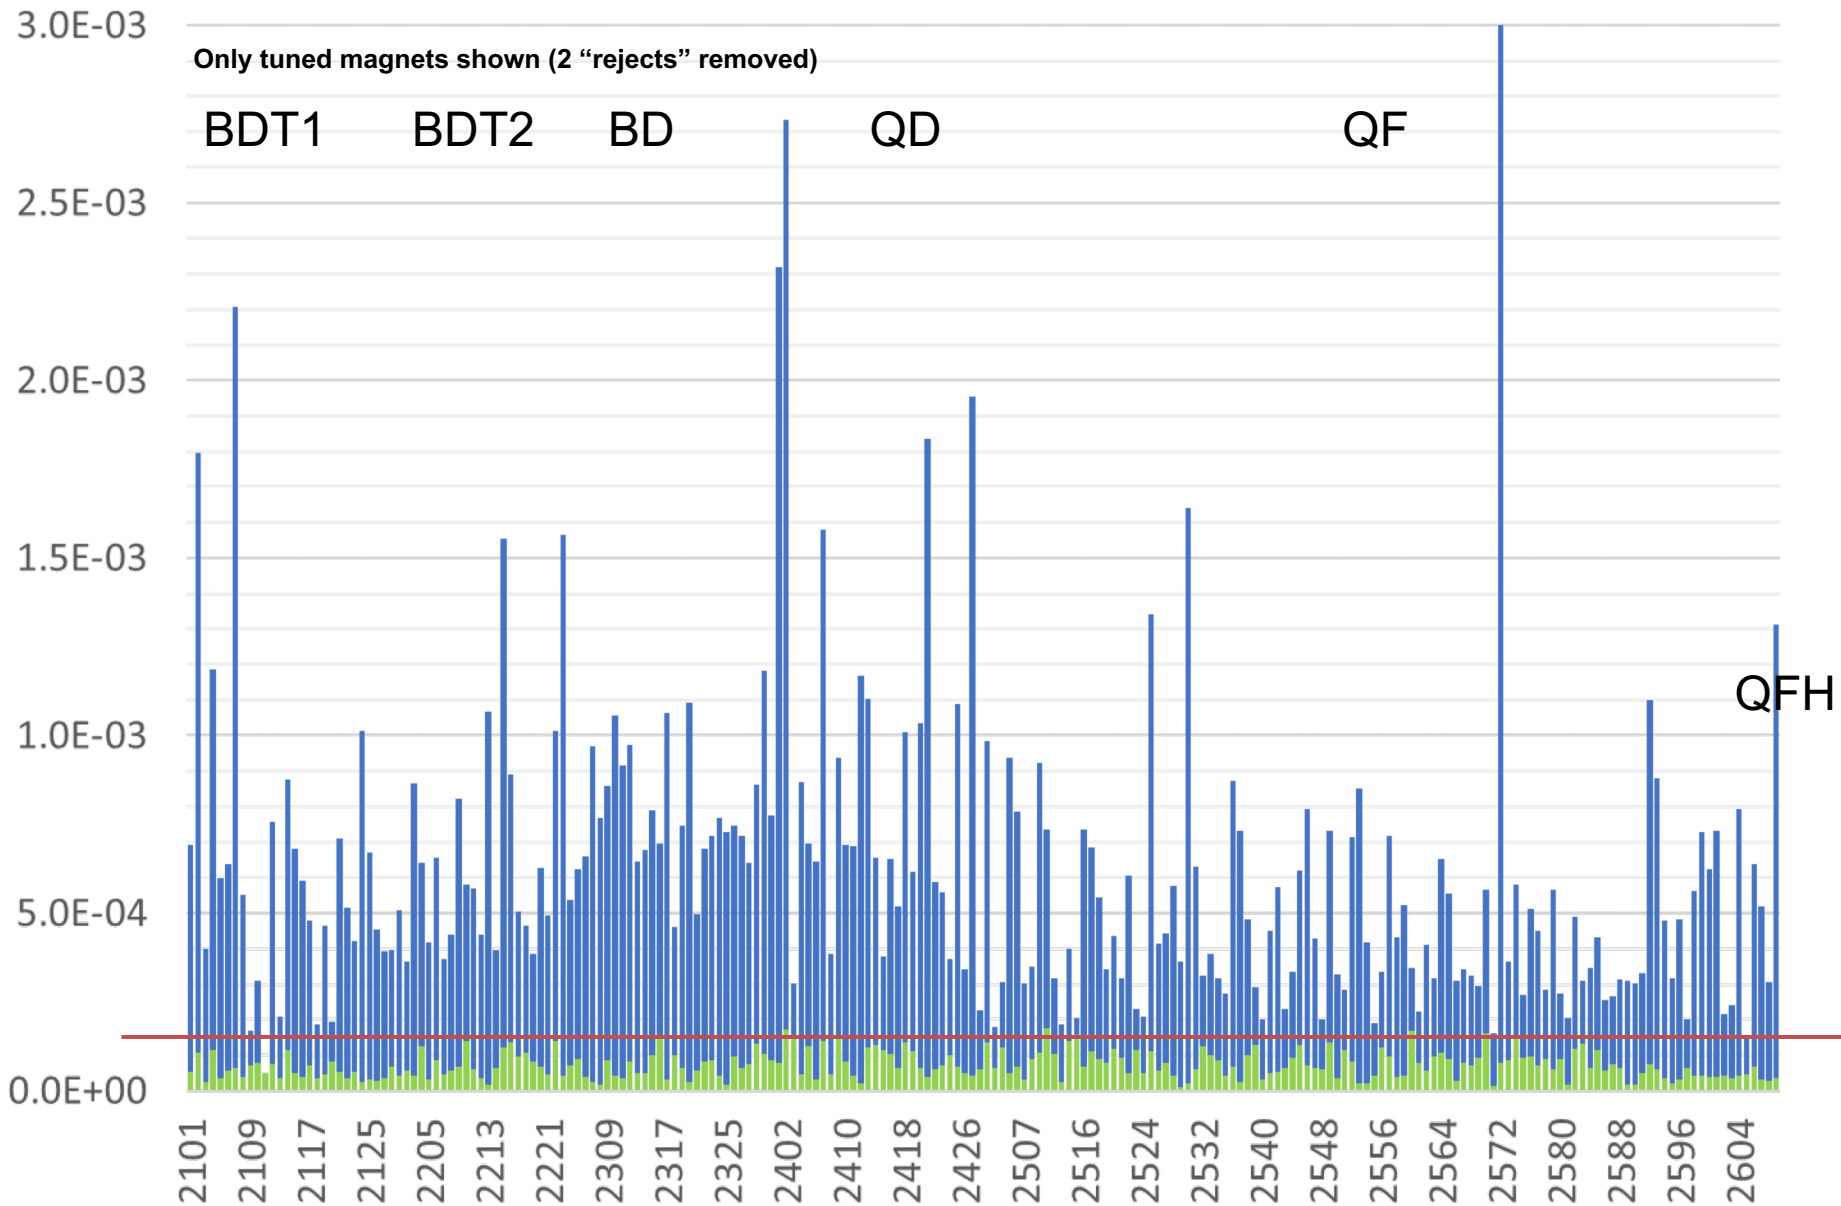
■ Initial max. midplane field error (T)

■ Tuned max. midplane field error (T)

- For full data see spreadsheets “initialmagnets” “finalmagnets”
- Midplane error generally hardest to achieve
 - May go in and out of spec slightly ($\sim 0.5\text{G}$) due to chiller cycle
- Achieving all the above triggers “quick accept”

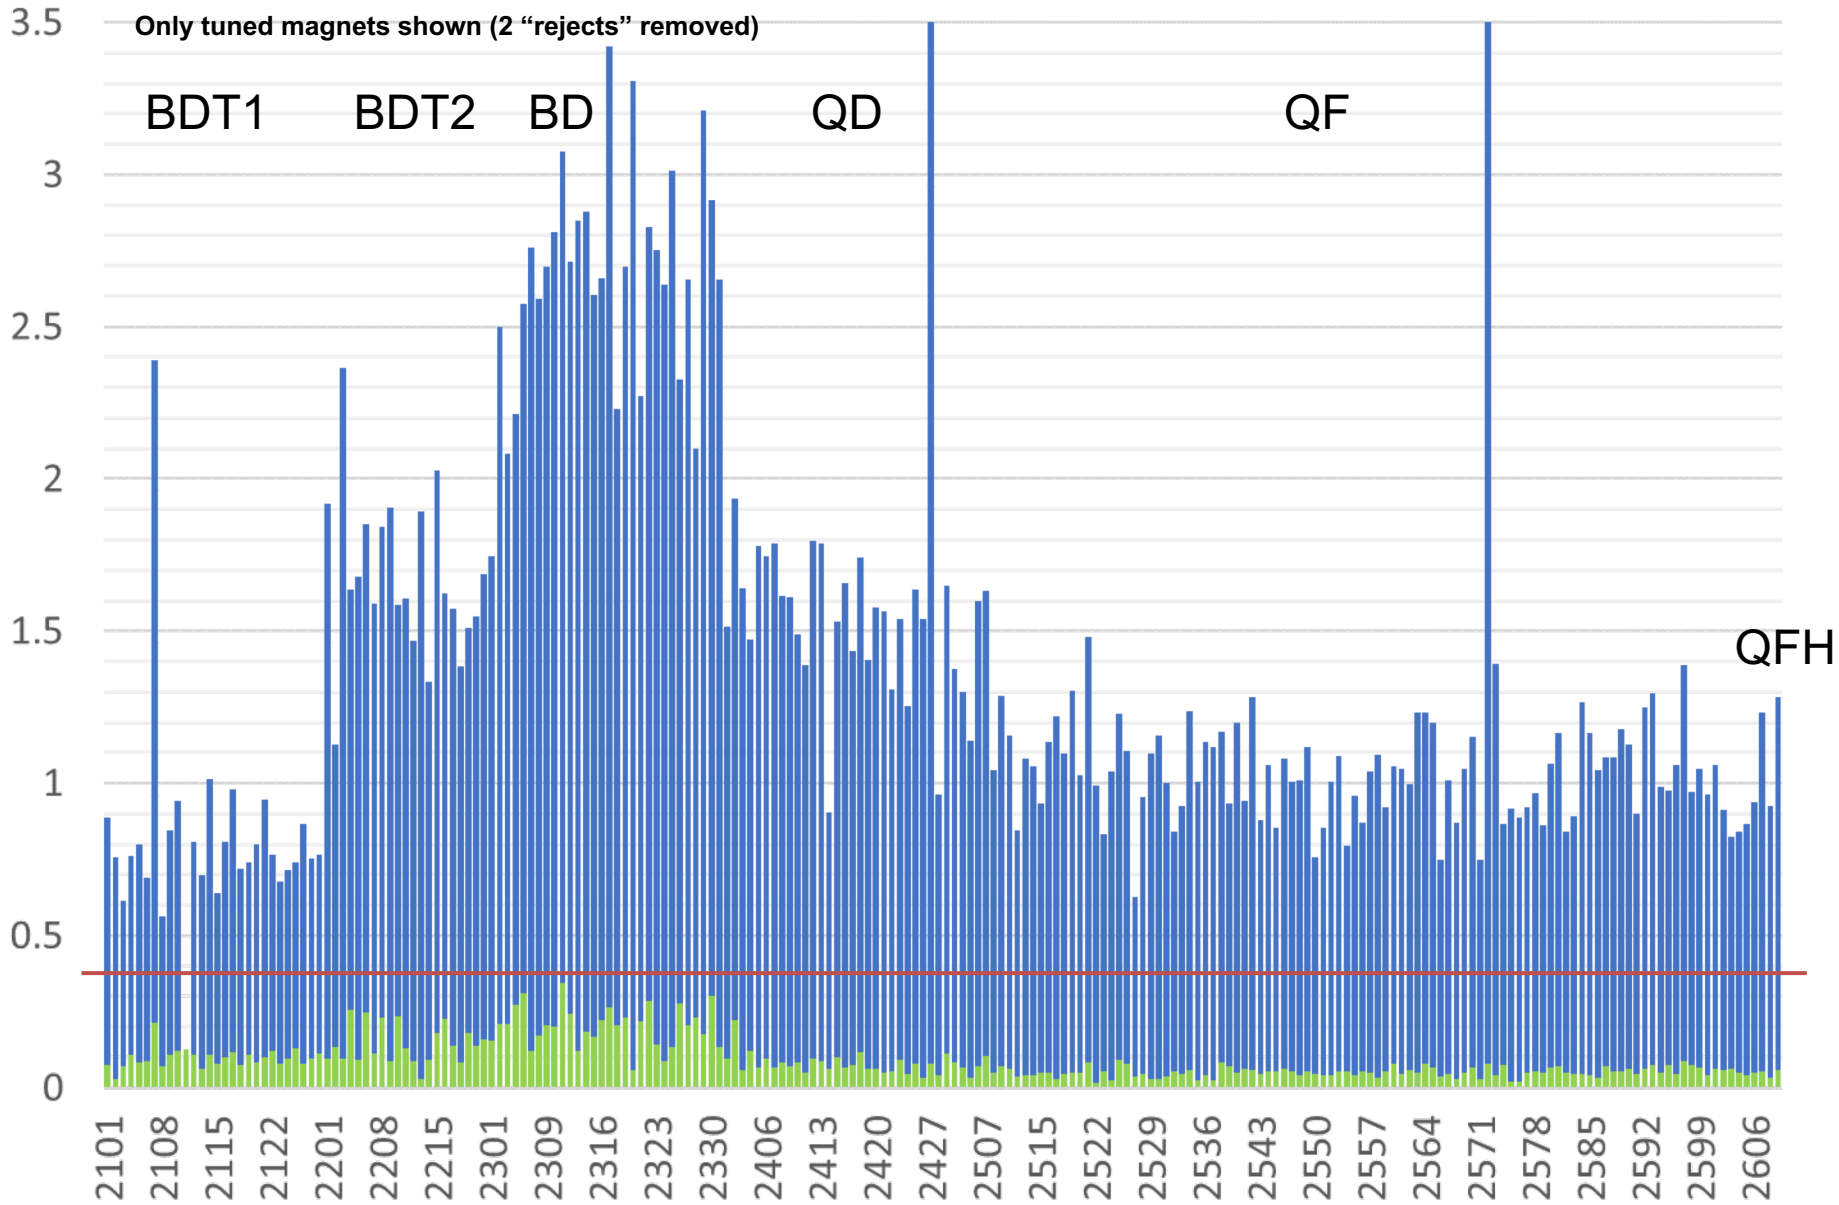
Initial CBETA_FOM Tuned CBETA_FOM
