BSM23W

Train 1 bunches

Pedestal subtracted

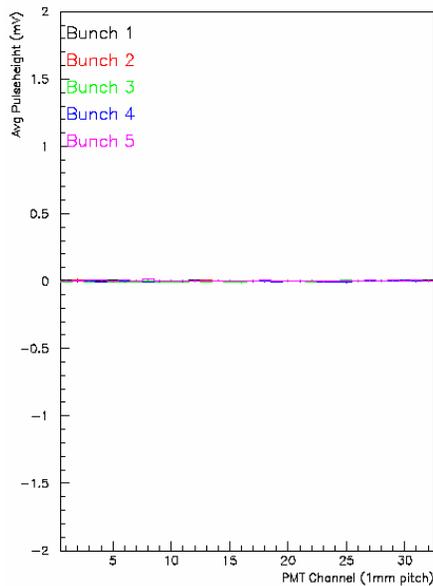
CESR off (17May2005)

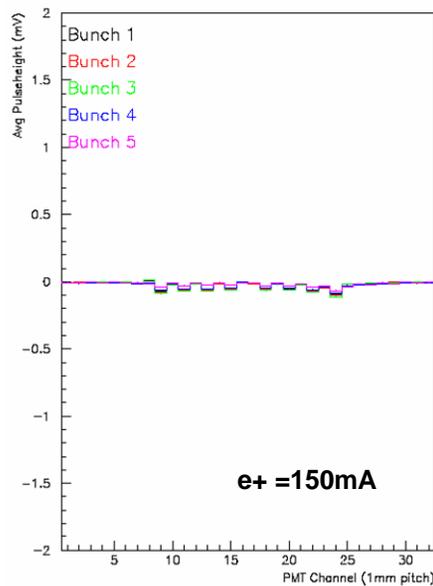
Flat cable disconnected on DSP side (17May2005)

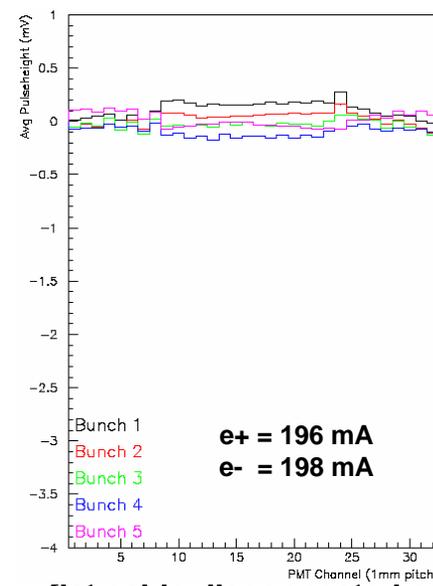
flat cable disconnected on PMT side (24May2005)

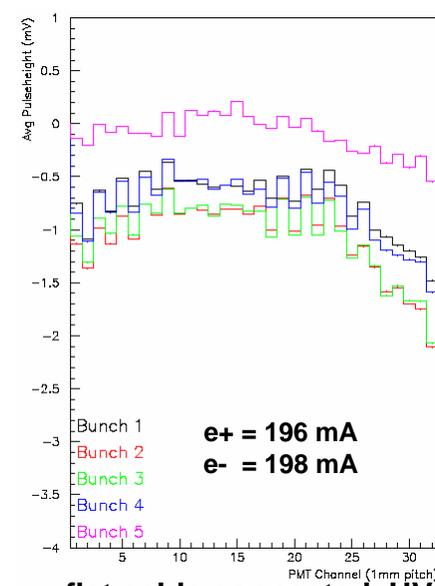
flat cable connected, HV cable disconnected on PMT side (24May2005)

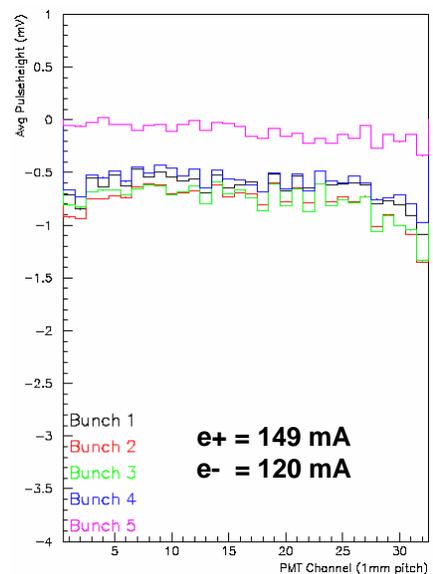
beam pipe window covered (0659)

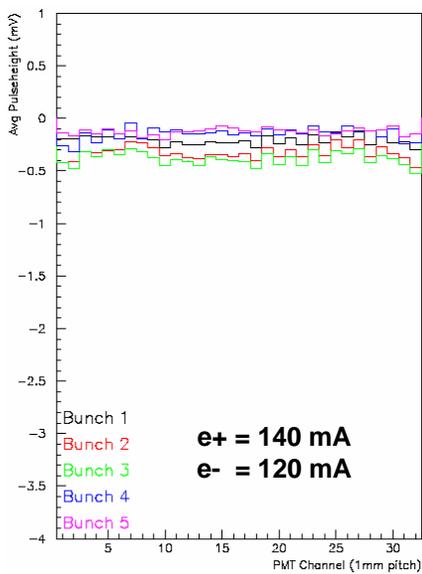
beam pipe window covered, PMT pc board isolated (0742)

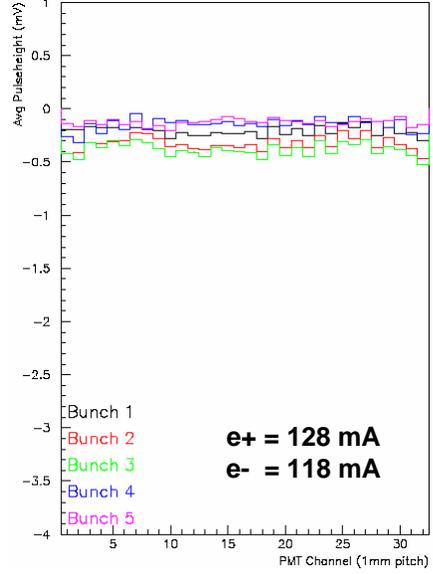
beam pipe window not covered, PMT pc board isolated (0758)
